THE USE AND VALUE OF AERIAL IMAGERY
FOR
PIPELINE INTEGRITY MANAGEMENT

ABSTRACT

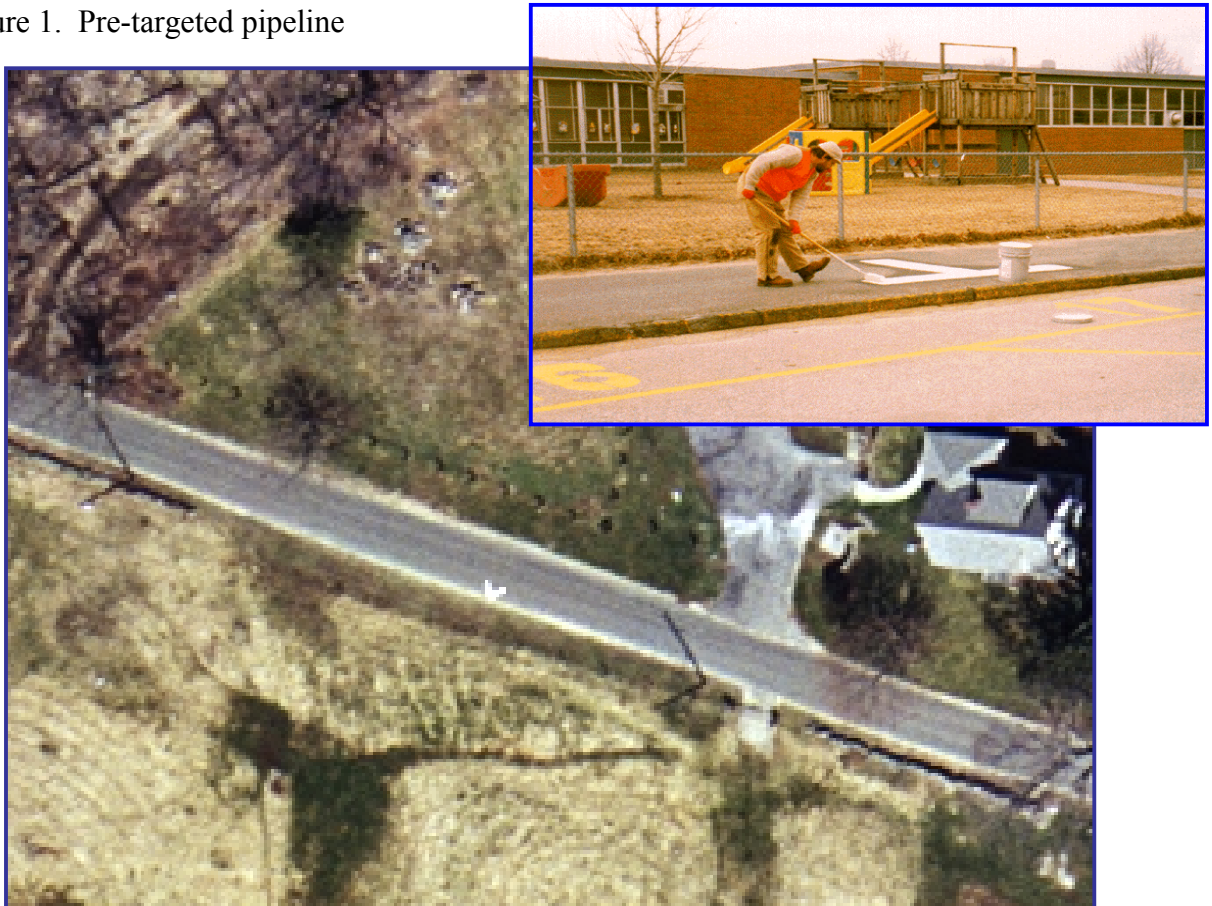
Figure 1. Pre-targeted pipeline

In preparation for the aerial imagery project, field crews used line locators to mark the pipeline in pre-determined locations, such as road crossings and other easily accessed areas. At these points, the centerline was accurately located using traditional tools and the points were targeted with photogrammetric style targets that could be located from the resultant orthophotographs.

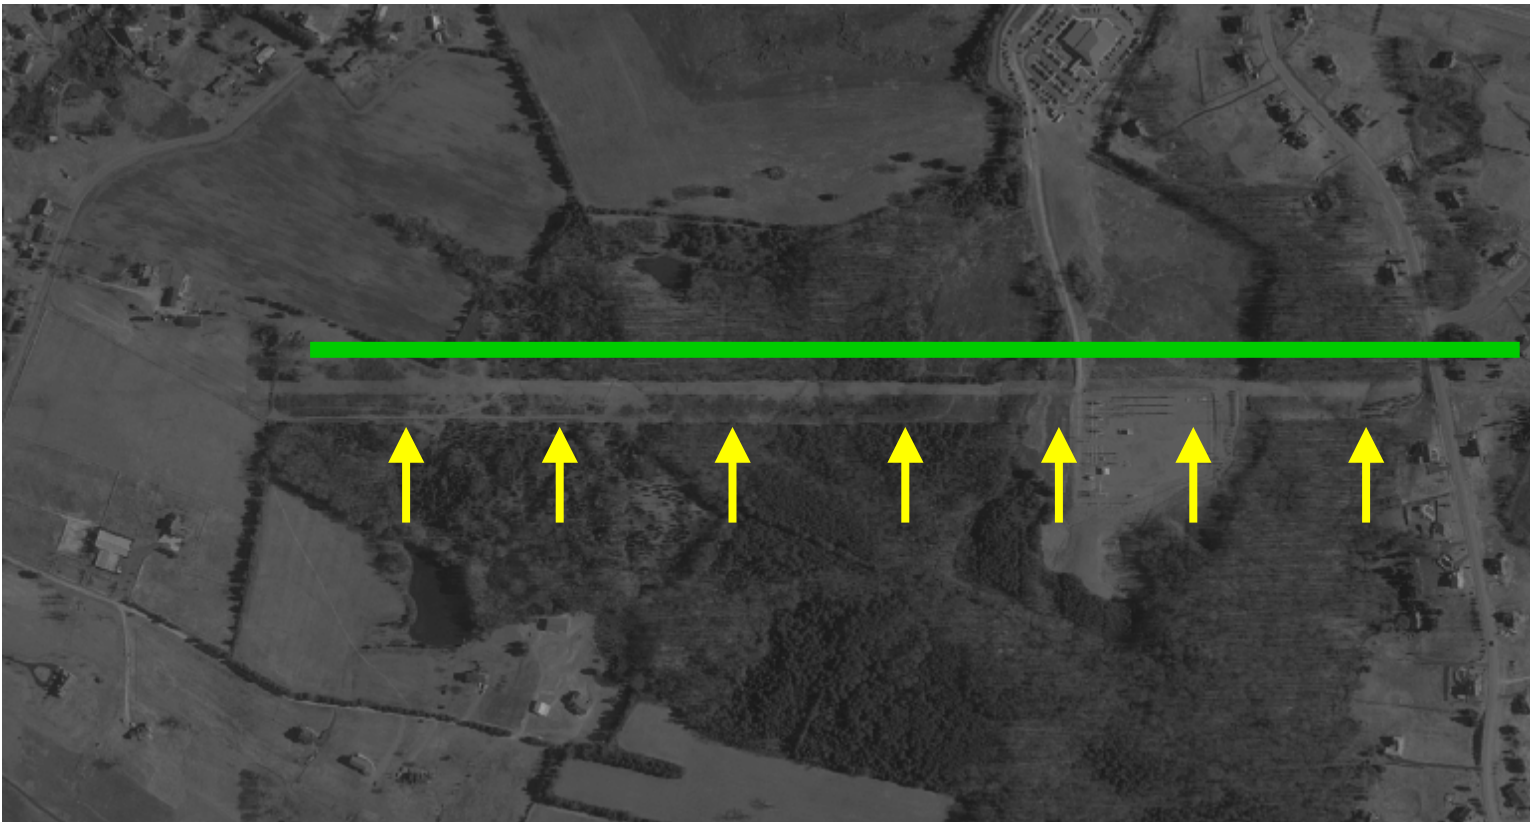
Figure 2. Re-alignment of pipeline route.

To perform the HCA analysis, this project required high relative accuracy of the structures as they relate to the pipeline. This was achieved by orthorectifying the imagery to the USGS DEM and using the pre-targeted pipeline points to route the pipeline on the orthophoto landbase.
